THE ROLE OF PHYSICAL ENVIRONMENT IN THE GENESIS AND AMPLIFICATION OF FLOODS IN NADOR (NORTHEAST MOROCCO)

The purpose of this study is identifying and mapping areas threatened by floods in Nador. The combination of different information layers dealing with land use, drainage network, slopes, lithology/geology and road network, using remote sensing and GIS tools provides vulnerability indicators and allows drawing a flood risk map. The objective is hazard causes understanding, to help early warning and to define the potential extent of flood in threatened urban areas.

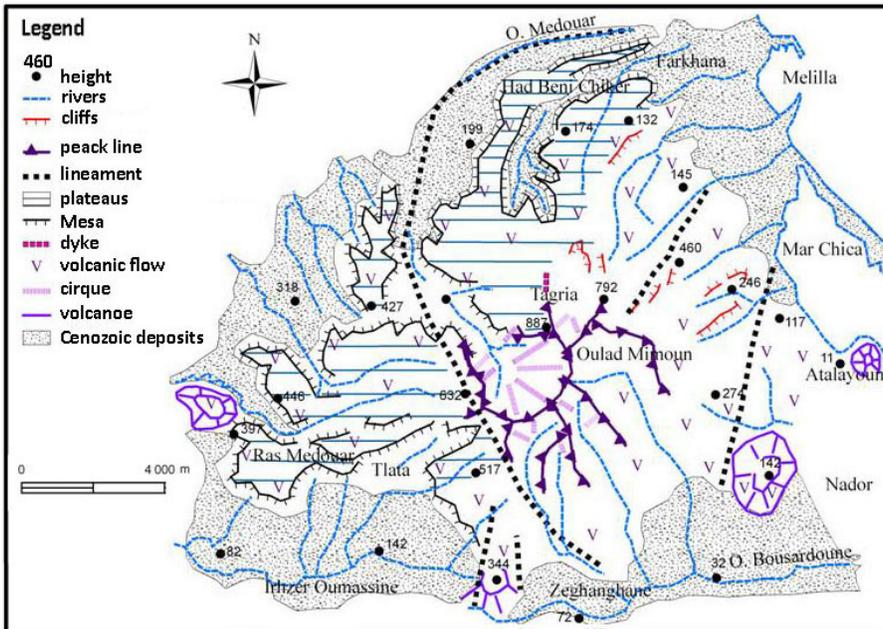
Figure 2. The main geomorphologic units of the massif of Gourougou.

Rising at 879 m, the Neocene stratovolcano (8 My) of Gourougou stretches about 25 km from West to East and 15 km from North to South, with steep slopes. In the south, the Beni Bou Ifrouh hills are shaped in Jurassic and Cretaceous rocks (schist, quartzite, limestone-marl and marl-sandstone), while low plain of Nador is an area of recent alluvial spreading (Miocene and Quaternary), (figure 2).

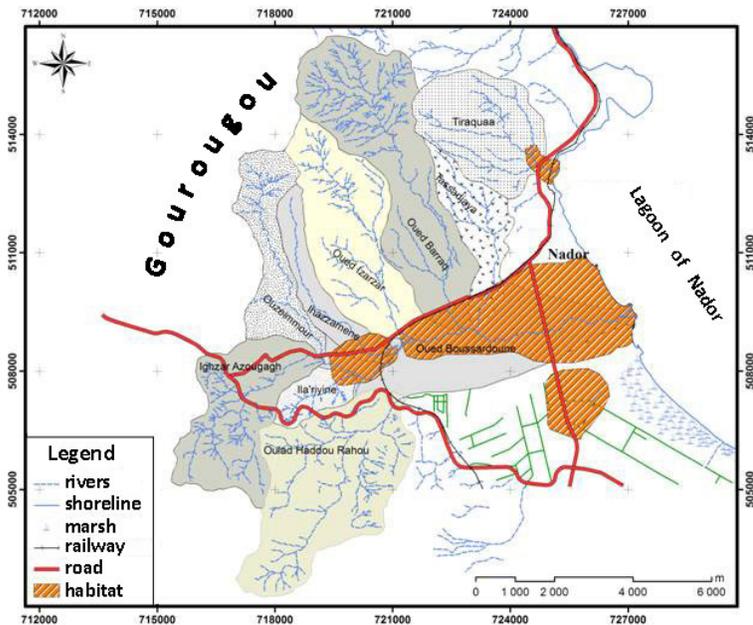
Figure 3. Watersheds.

The eight tributaries of Oued Bousardoune drain a watershed of area of 72.7 km² (Figure 3). The shapes of recorded hydrographs are related to morphological characteristics, besides the nature of the downpour. Several formulas and indices allow decrypting these features (Table I).

Gravelius compactness index defines the shape of the drainage basins: in this case, it ranges from 1.16 to 1.83, reflecting a relatively elongated watershed. The main course has an index of 1.6. It forms a powered linear valley, especially on the left bank, by a succession of tributaries (Figure 3). This situation favors further flood waves growing downstream, while supported from the tributaries. Irhzer Ouled Haddou, drains the massif of Beni Bou Ifrouer with a steepness of 1%, whilst steepest valleys lie in the Gourougou massif with values of 5 to 10% (O. Berraq, O. Izarzar, I. Ihazzamene).

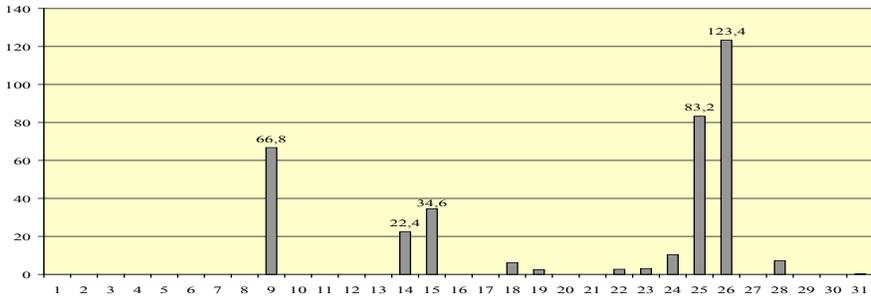
Figure 4. Rainfall in October 2008.

The year 2008-2009 began with very heavy rainfall. On 25 and 26 October 2008, heavy rain fell on the region of Nador. They reached 123 mm in Nador and caused violent and devastating flooding. (Figure 4).

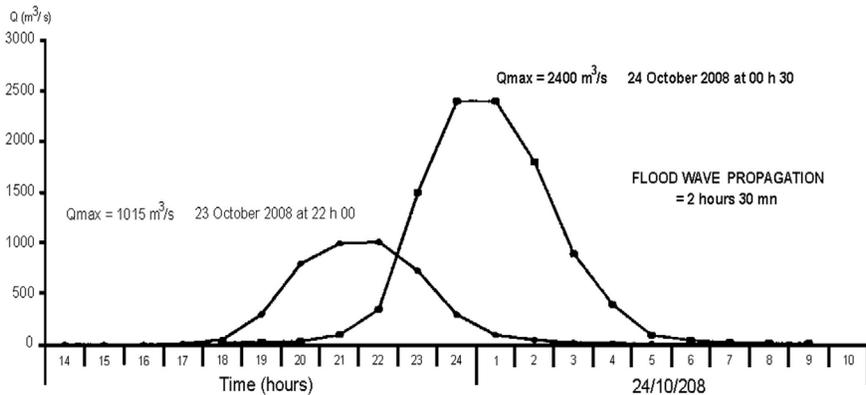
Figure 5. Oued Kert flood hydrograph.

Due to a great thunderstorm, one of the most deadly and devastating flood occurred on 23-24/10/2008, lasting only 8 hours, but rising barely in 3 hours. The peak value of 2400 m³/s was reached at Dar Driouch on 24/10/2008, at 00:30, mobilizing a runoff volume of 35.5 million m³ (Figure 5).

The hydrograph sharpness highlights the monogenic simple flood with a strong tip, fairly short rise and drop with an extended depletion (Sbaï *et al.* 2010). Oued Bousardoune as well as Oued Tiraqaa cause severe flooding downstream in Nador city, constantly threatened by flow deposits and narrowing due to uncontrolled urbanization.

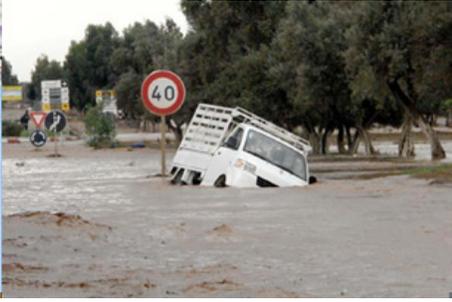
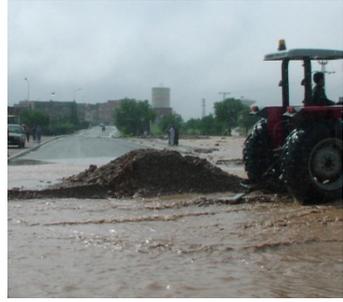
Floods that could have serious consequences are quite frequent in Northeast Morocco. They make roads dangerous and unusable (Photos 1, 2 and 3).

Photos 1-2-3. Examples of flood damage in Nador city (2008)

On 26th October 2008, Nador city and suburbs experienced a powerful unexpected brutal flood. According to official report, 4 people died and several buildings and roads were damaged, hundreds of victims relocated, drinking water supply cut, power network damaged, wells and irrigation channels, roads, bridges, all affected.

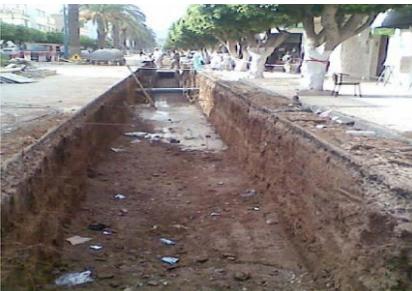
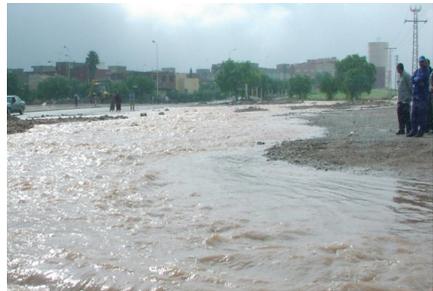
Photos 4-5: A rainwater channel (2009) to reduce flooding; flood in Nador (2008).

Although an emergency plan was adopted earlier in the 1990s to protect Nador, after this disaster event, structures were needed to intercept carried sediment load.

Several development works have been completed or are underway: overflow protection system re-establishment within streams, trapezoidal channel structures (bays, coating stairs, falls), bridges building and restoring, riverbed cleaning, landscaping slopes.
